ABOVE GROUND STORAGE TANK PROTECTION

McCook County Highway Department Salem, SD

Fortify 3 year old paint beginning to fail on an above ground asphalt storage tank

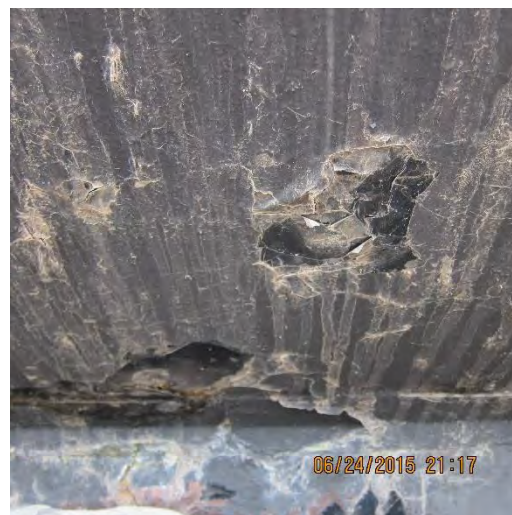
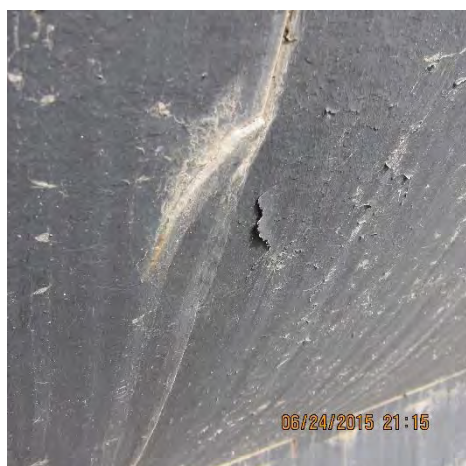
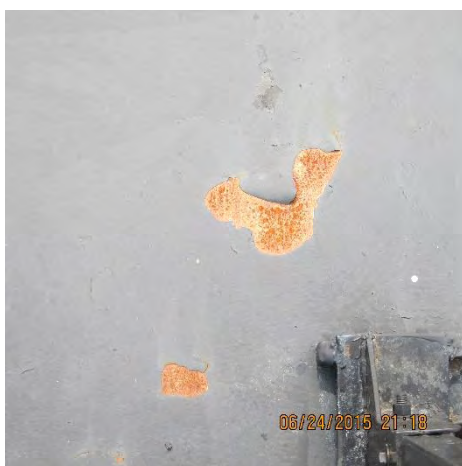
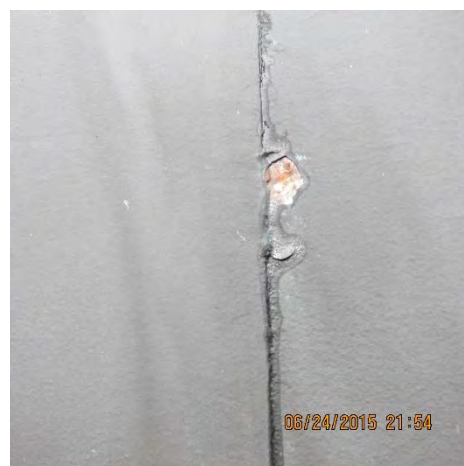
Over the years exposure to the UV and weather deteriorated the paint system resulting in oxidation to all of the paint on the storage tank.

There were areas the paint had peeled away from the substrate.

In some areas the paint had fallen off exposing the steel substrate forming rust which will result in asset damage in terms of structural material loss.

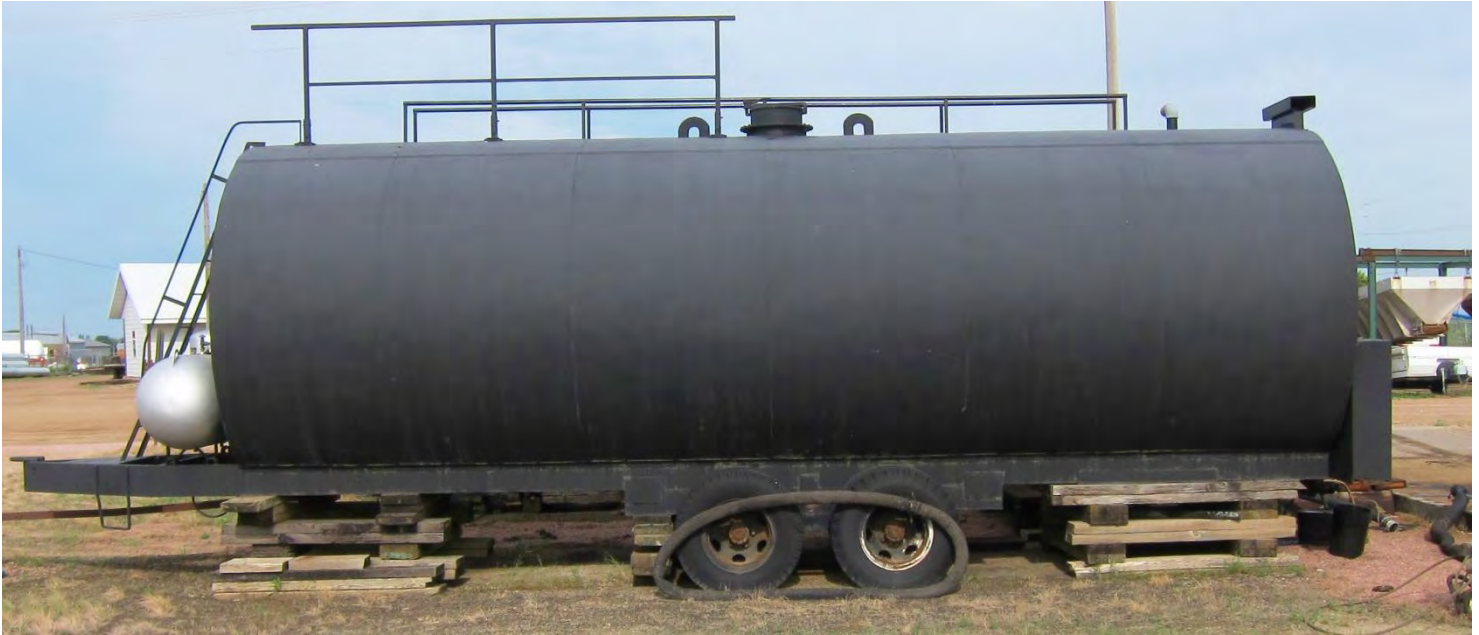
Storage tank **before** the application of **NCI** on June 25, 2015.

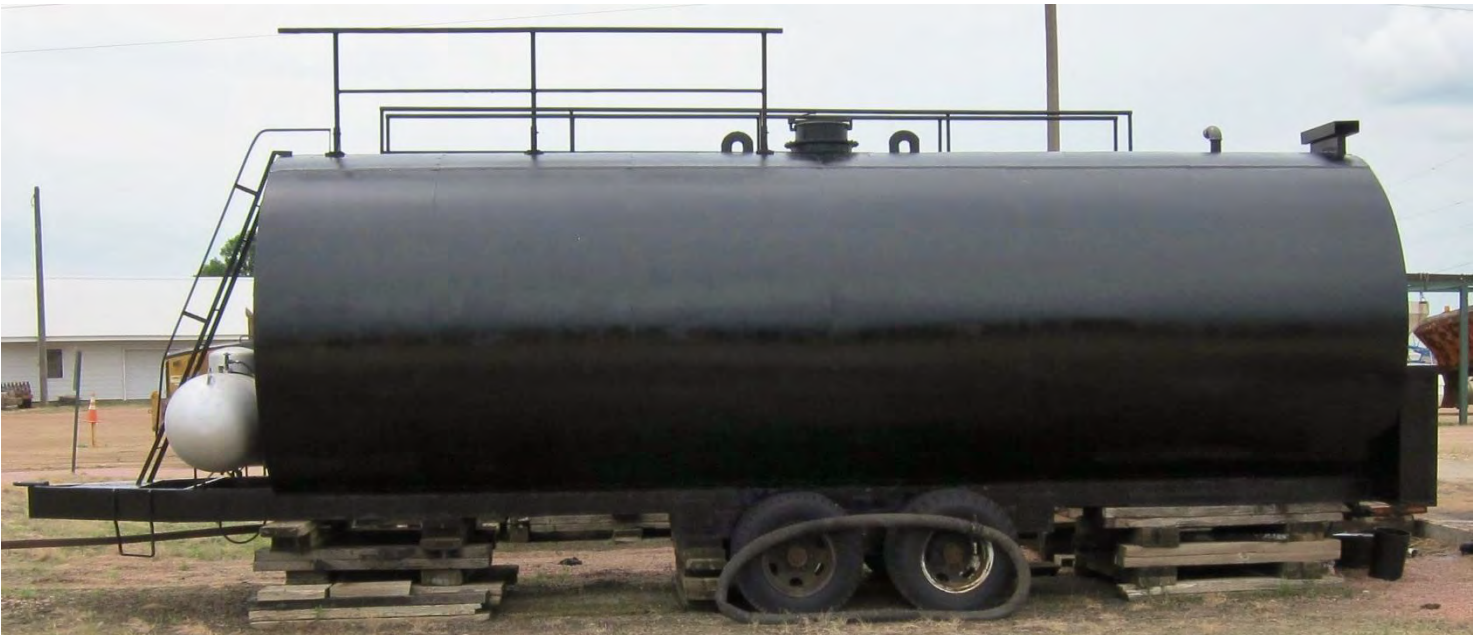
Storage tank **after** the application of **NCI** on June 25, 2015.

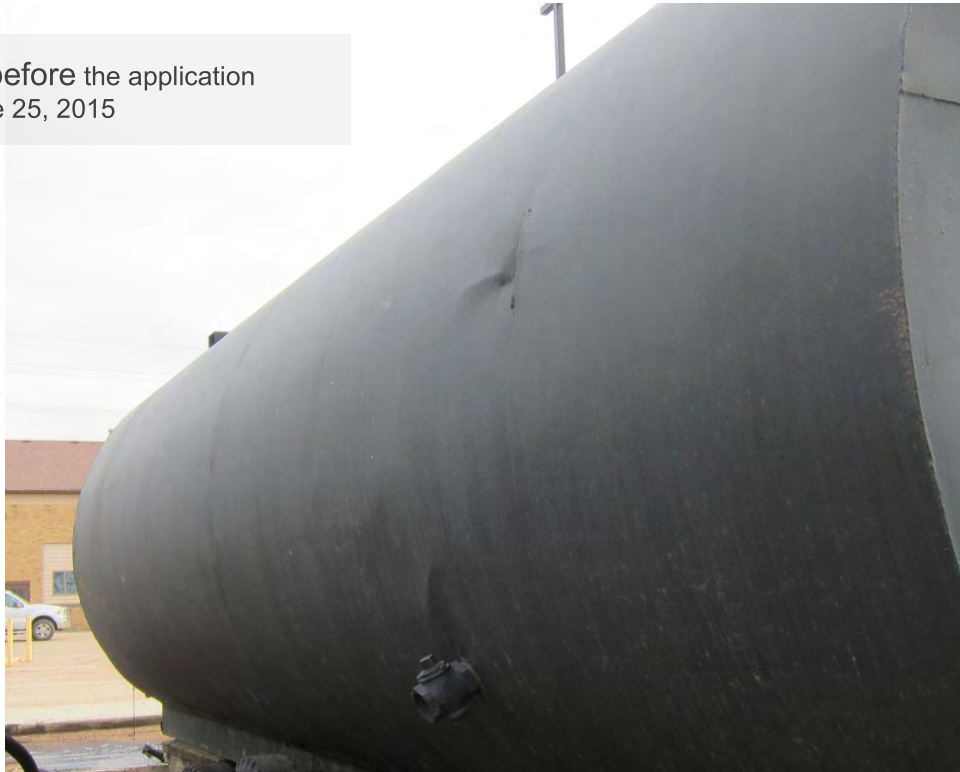
Storage tank **before** the application
of **NCI** on June 25, 2015

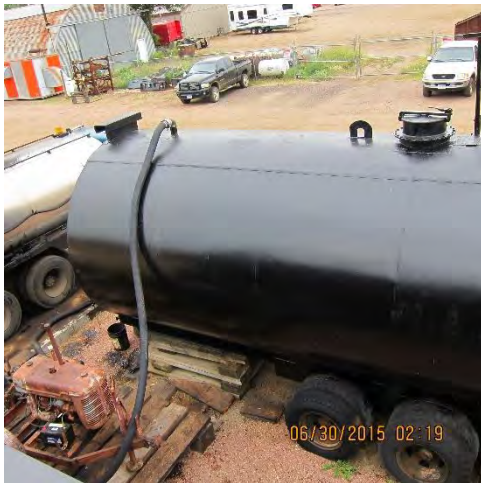
Tank #1 End – NCI

The photos of end, middle and front sections of the **NCI** coated storage tank are on the top row and the corresponding section of the storage tank that did not receive the coating is directly beneath them on the bottom row.
The difference is remarkable.
