NANO-CLEAR INDUSTRIAL COATING FOR OXIDIZED WATER SLIDE

Fortify oxidized fiberglass and enhance the color on the exterior of the water slide in the Drake Springs aquatic center.

REPORT

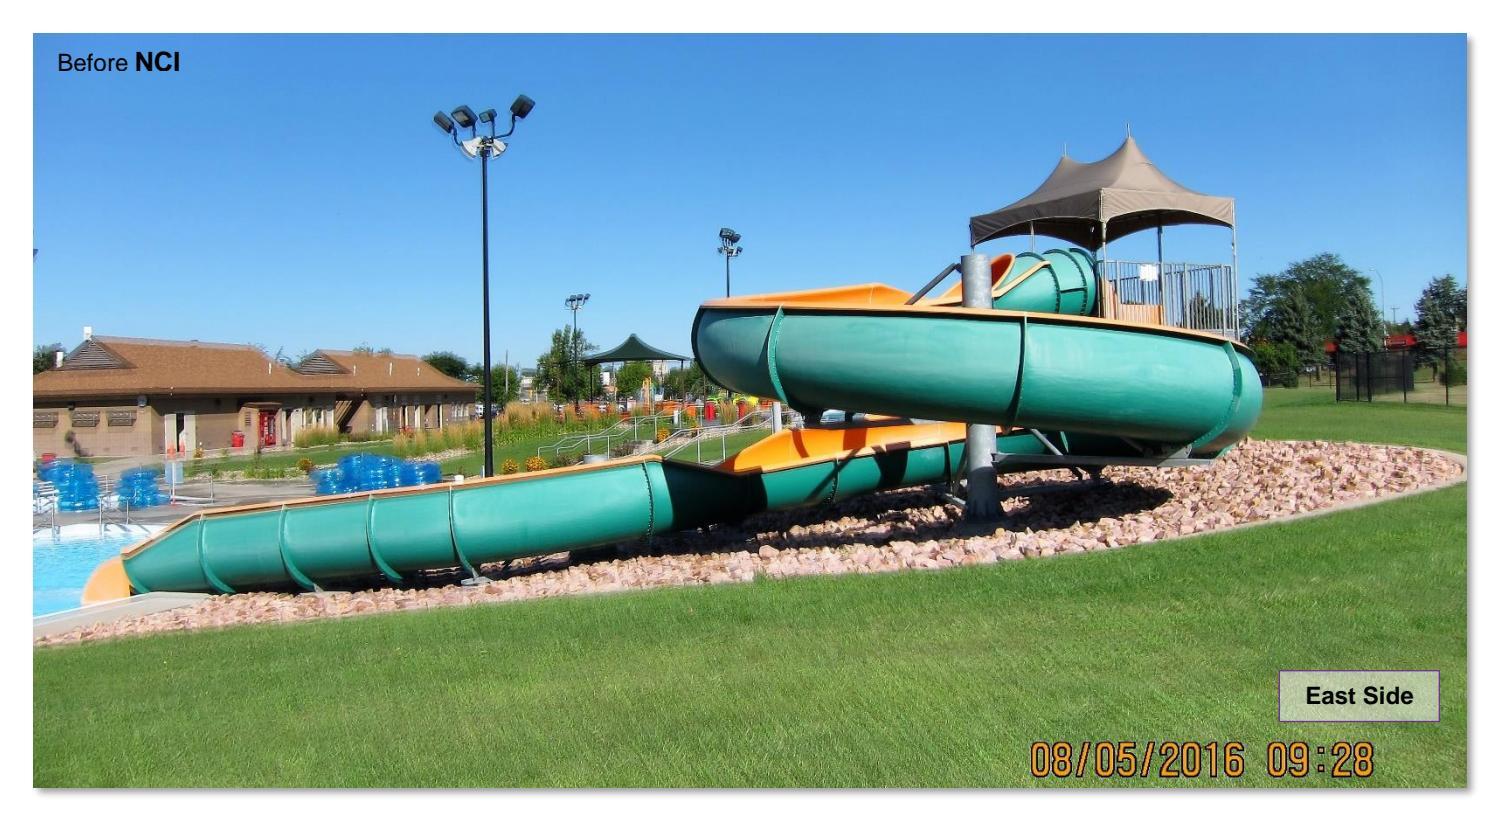
The water slide at Drake Springs was installed in 2009. After years of outdoor exposure to the elements, pool water and use, the exterior of the fiberglass water slide in the Drake Springs Aquatic Center had become oxidized and faded.
